# Fly Creek Pumping Station

*Inspection*

Raisin Region  
Conservation Authority

January 30, 2019

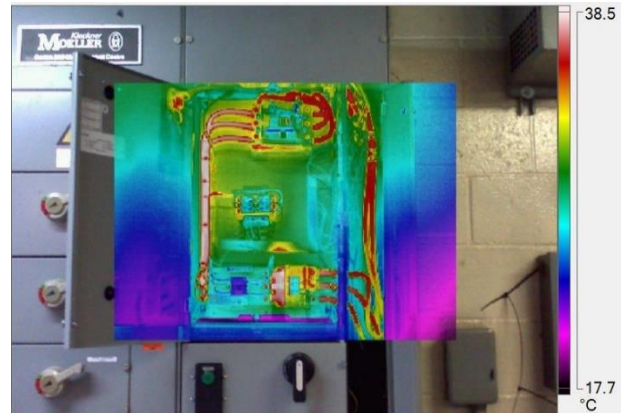
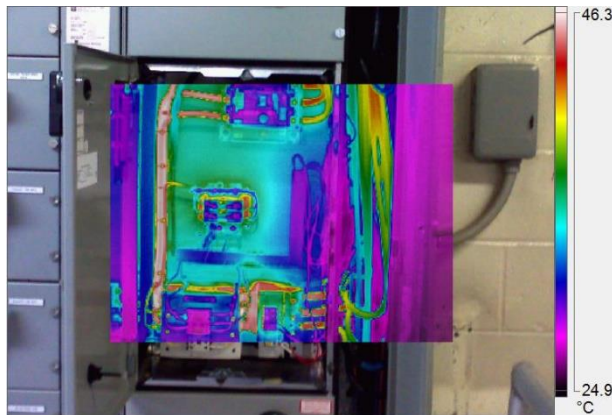
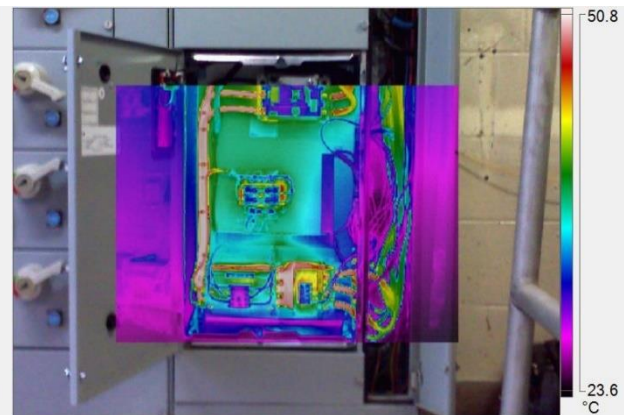
**Figure 5: Infrared Scan - Motor Panel 1**

**Figure 6: Infrared Scan - Motor Panel 2**

**Figure 7: Infrared Scan - Motor Panel 3**

An infrared inspection was performed on all three buckets with a pump in service. The results indicated that the wiring was in good shape and that operating temperatures were within normal ranges. All electrical components within the motor control centre are properly working and fully operational.

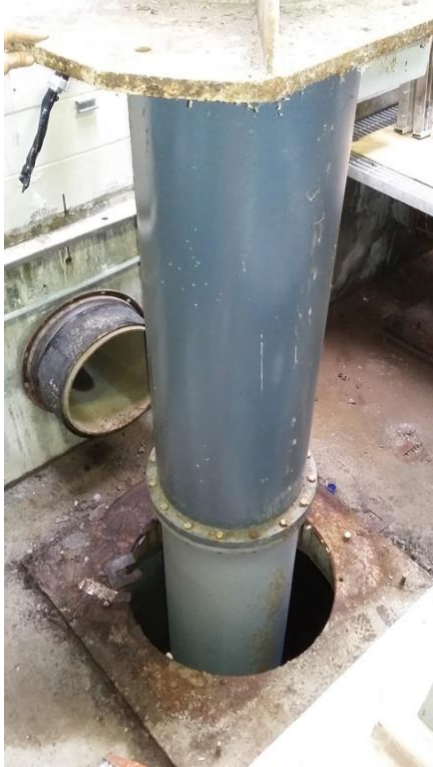
Pump #1 had been experiencing rough start-ups and would often cause the breaker to trip. The observed start-up issues on this pump strongly suggest some initial wear has occurred on this pump's lower column bearing / bushing. This is likely resulting in some propeller – column contact at initial start-up that stabilizes on the pump comes up to speed. It was disconnected and removed for inspection. It was determined that the pump was in poor condition and severely pitted. Additionally, the soleplate was noted to be severely corroded. It was agreed not to reconnect Pump 1 and to take it out of service until it can be refurbished.

**Figure 9: Pump 1 - Removal**

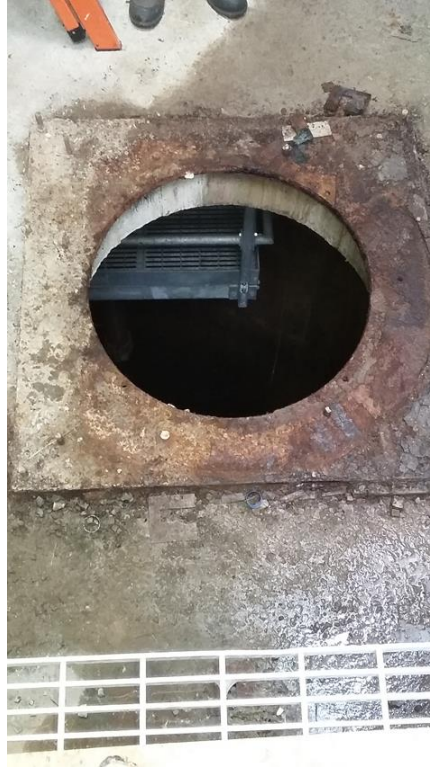
**Figure 10: Soleplate 1 - Corrosion**

5. Replace Soleplates for Pump #1, Pump #2, Pump #3.
6. Clean motor windings for Motor #1, Motor #2, Motor #3.
7. Overhaul Motor #3.
8. Repair hour meters on Pump #2 and Pump #3 motor control cabinets.

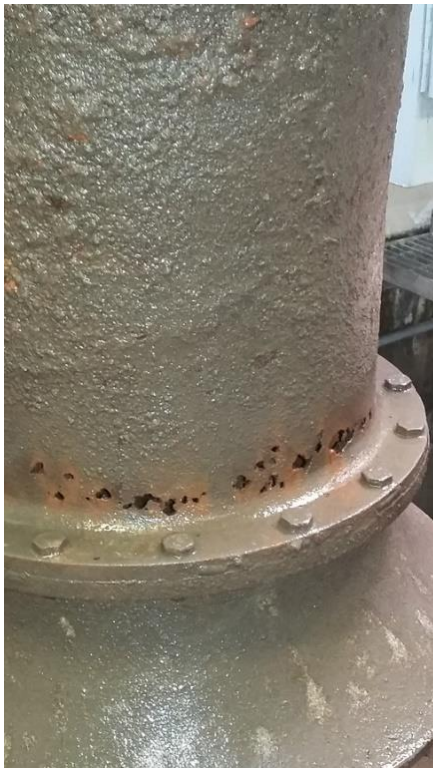
**Figure 11: Pump 1 - Pitted Suction Bell**

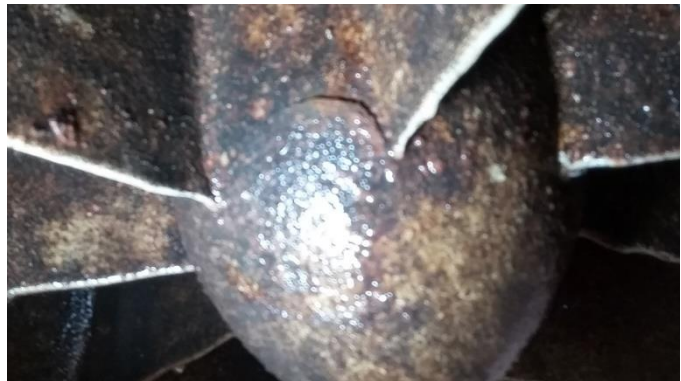
**Figure 12: Pump 1 - Corroded Impeller**

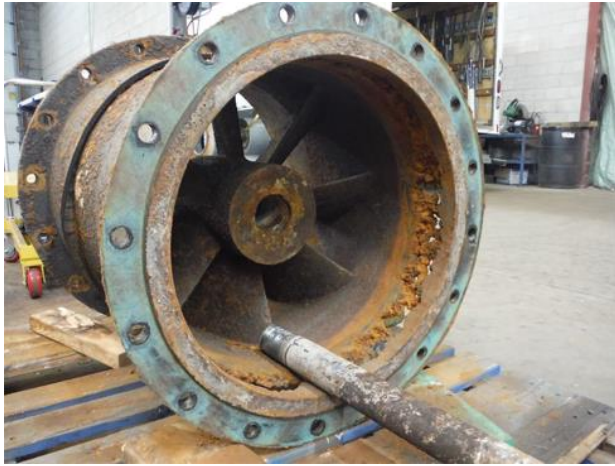
**Figure 13: Pump 3 – Pump Case Cavitated**

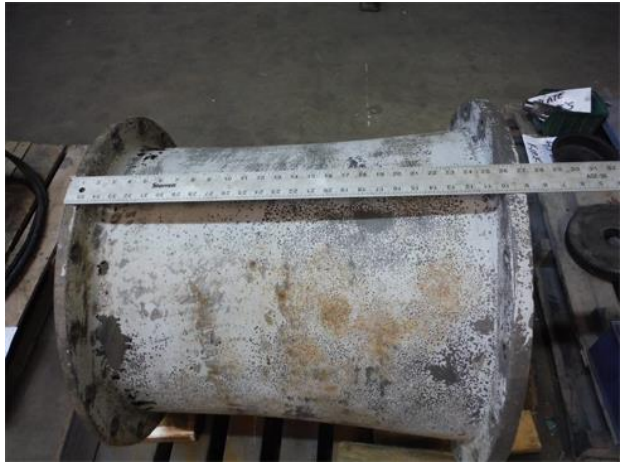
**Figure 14: Pump 3 – Case wear from cavitation**

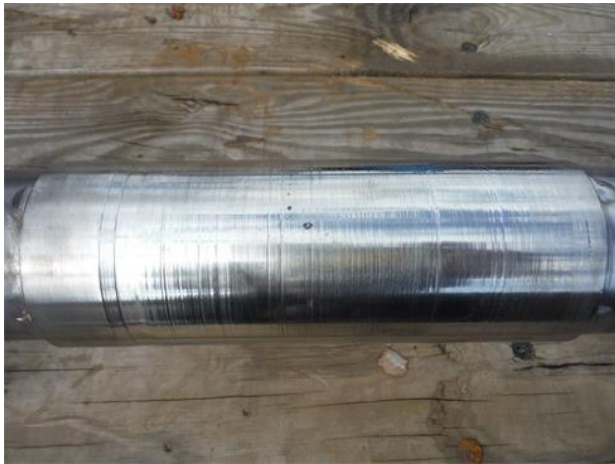
**Figure 15: Pump 3 – Worn shaft sleeve**

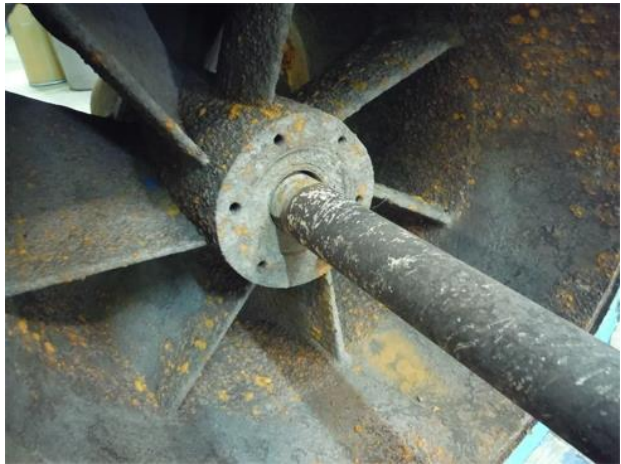
**Figure 16: Pump 3 – Pump bearings severely worn**

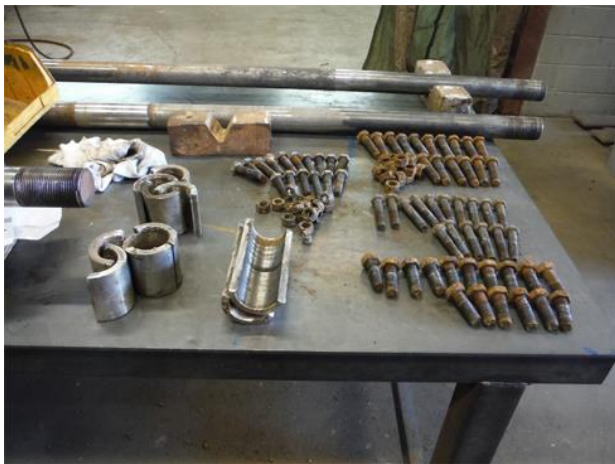
**Figure 17: Pump 3 - Worn shaft couplings and bolts**

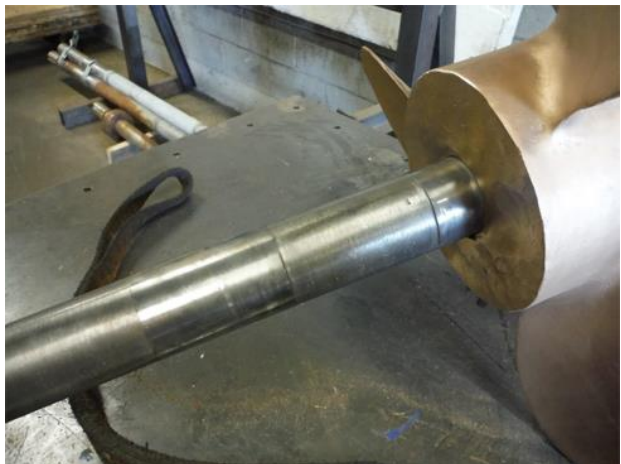
**Figure 18: Pump 3 - Deep shaft wear near impeller**

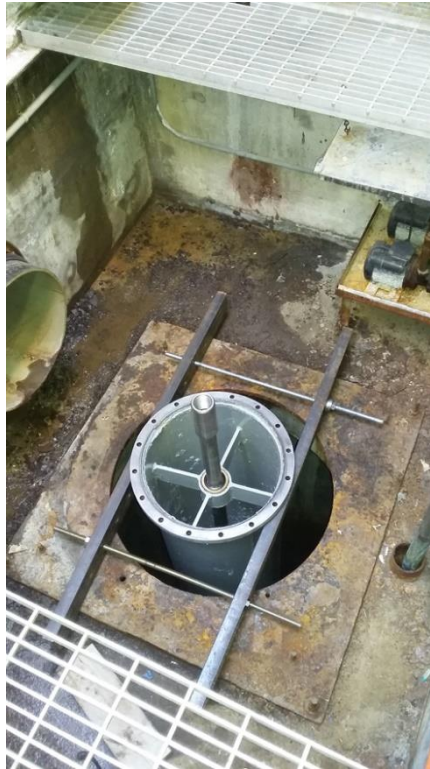
When Pump #3 was re-installed it was noted too that the soleplate was corroded and requires replacement as it is not likely to provide a stable base for operation. The motor was also found to be out of balance. It was rebalanced; however, vibration analysis indicates that there is likely a bearing defect in the motor that requires immediate attention. There is some minor leaking on at the discharge gasket of this pump which should be monitored.

**Figure 20: Pump 3 - Soleplate Corrosion**

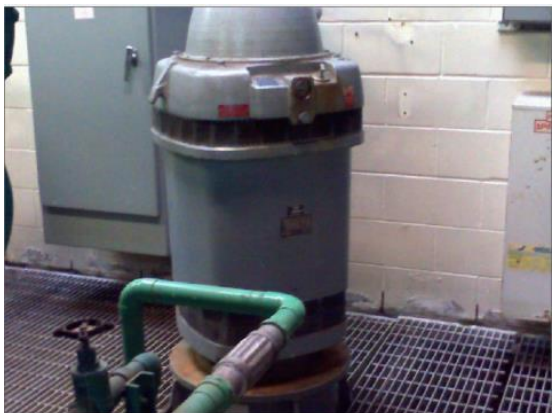
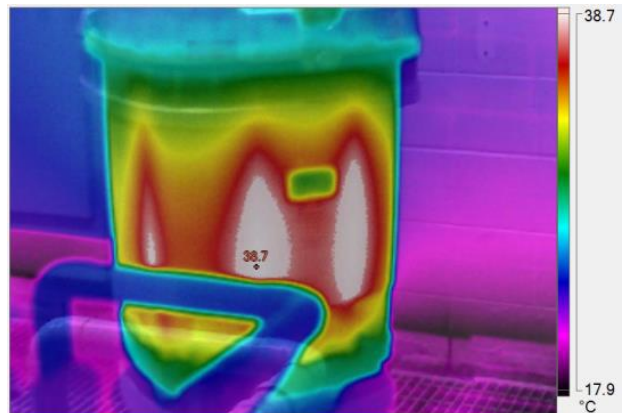
Previous infrared testing on the motors indicates that (other than motor 3 having a vibration issue) the motors are generally in good condition. However, it is suspected that they are drawing excess current on Startup and as a result occasionally tripping their breakers. This is likely because the motor windings are dirty. It was recommended that the motor windings be cleaned.

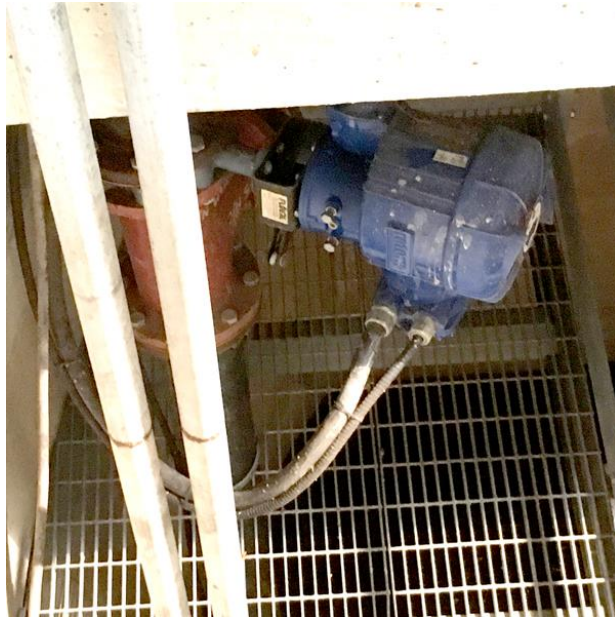
**Figure 31: Wetland Diversion Actuator**

The diversion actuator appears to be in good physical condition; however, at the time of inspection it was not possible to check the operation due to the controls having been removed during the last SCADA system update. Moreover, as the dewatering pump has not been working as of late, it is not possible to check the flow to the wetland. The wetland fountain head, which is to be removed for the winter, appears to still be in good condition. The wetland itself has seen some significant seepage in the past few years and may be compromised through rodent burying.

It is recommended that the actuator controls be reinstated and tested, and that the wetland embankments be examined and repaired.

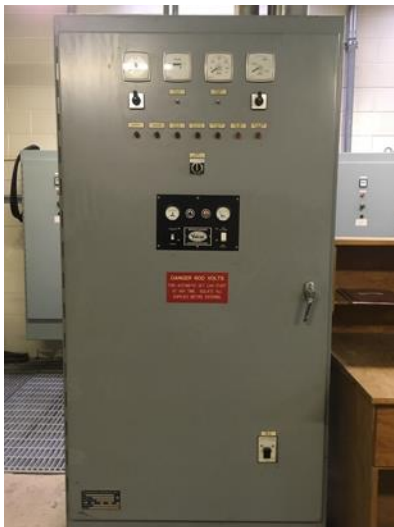
Figure 35: Automatic Transfer Switch

The diesel engine and generator set have been shown to be in good working order. Startup and operation work as intended. The automatic transfer switch has shown a recent deficiency in that it does not properly signal the generator to turn off when power is restored. This has caused the engine to run until it runs out of fuel.

9. Retrieve dewatering pump and service / repair.
10. Reinstate wetland valve/pump actuator.
11. Repair seepage issue with wetland.
12. Repair automatic transfer switch (not turning off diesel engine upon restored power).

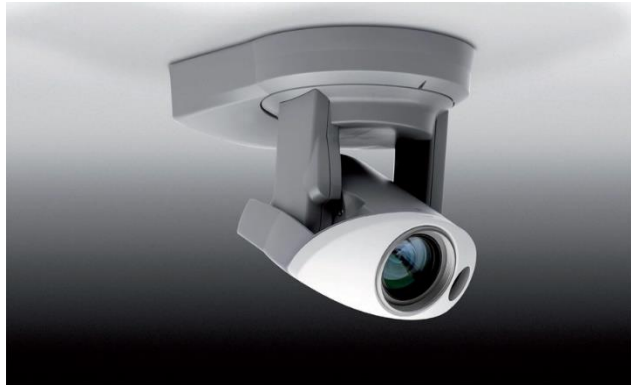
**Figure 46: Surveillance Camera (Mfr. Photo)**

The current surveillance camera is non-functional, and the VPN connection has been disconnected. The camera is not critical to pumping station operation; however, it is an extremely useful tool. For example, an operator can make a quick visual check of water levels in the pond and make a remote assessment as to the proper operation of the pumping station. It is recommended that the camera be replaced or repaired immediately.

It would also be recommended that a security camera system be installed within the pumping station too. For a relatively low expense, this would enable the operations staff to review and possibly trouble shoot alarms remotely. It would enable staff add additional monitoring without the expense of physically visiting the pumping station.
