**The Corporation of the City of Cornwall**  
**Regular Meeting of Council**  
**Report**

Department: Infrastructure and Municipal Works  
Division: Environment  
Report Number: 2020-405-Infrastructure and Municipal Works  
Prepared By: Bill de Wit, Division Manager  
Meeting Date: November 23, 2020  
Subject: Repair of Wastewater Treatment Plant Travelling Bar Screen

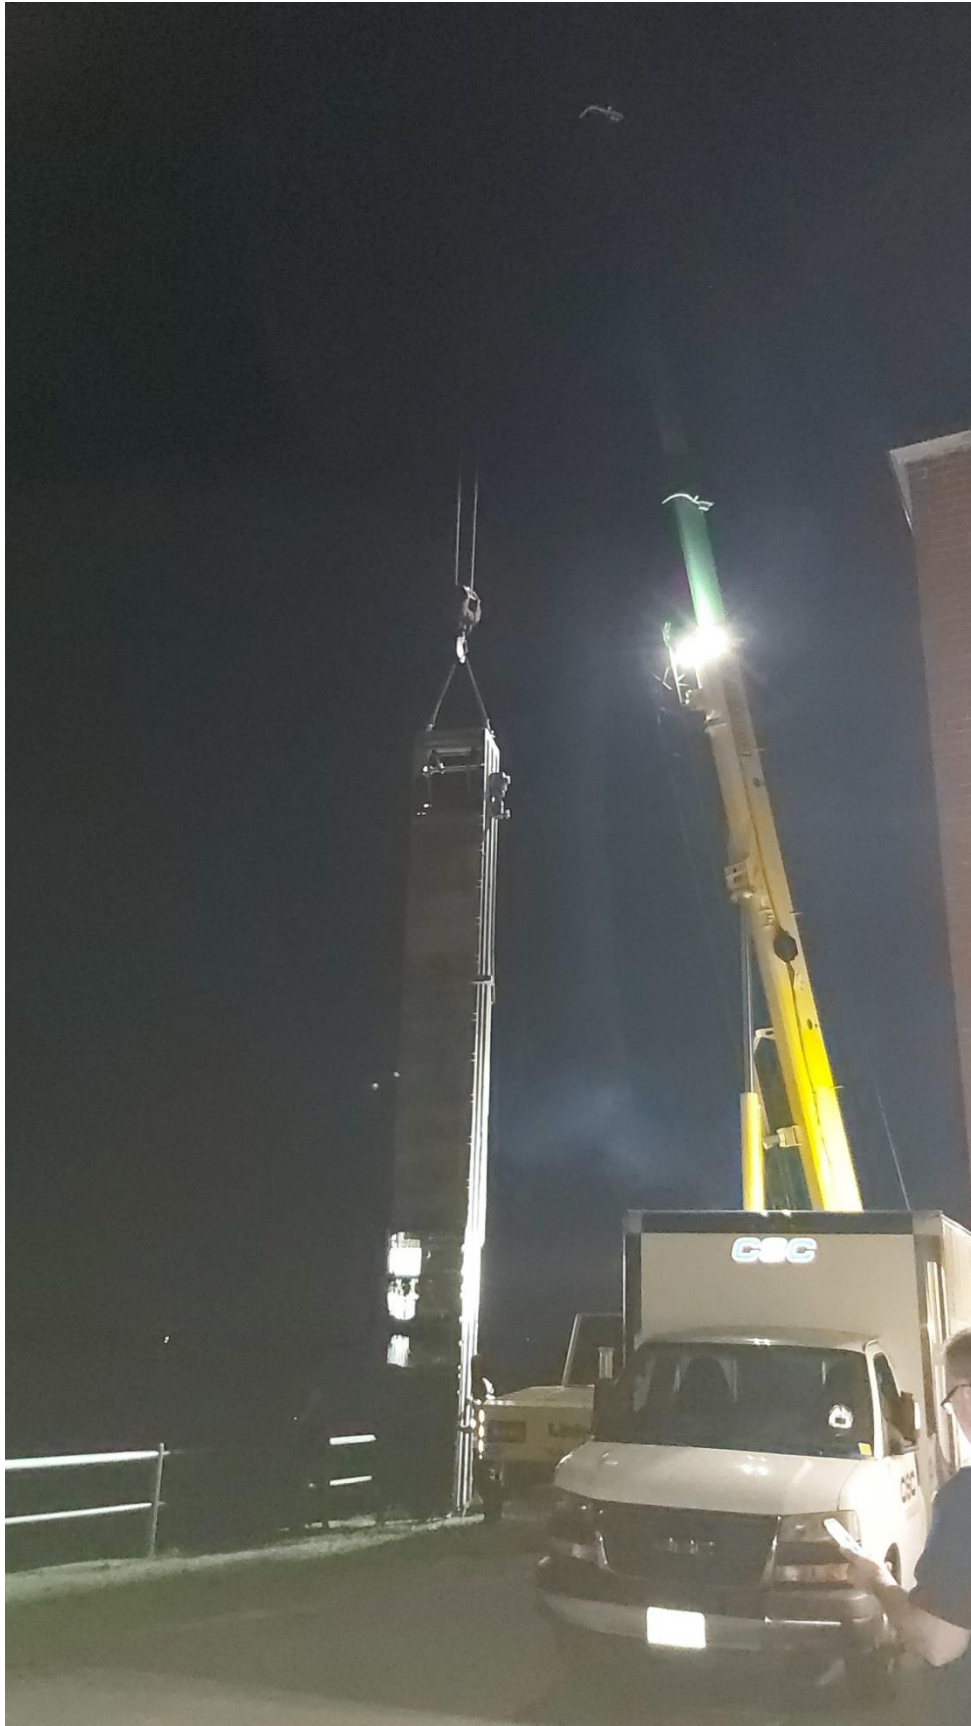
All sewage collected by the interceptor is passed through a preliminary screening process at the raw water pump station. The screening device, described as the travelling bar screen, traps floatable debris (sanitary wipes, cleaning swiffers, paper towels etc.) from the incoming raw sewage. This debris has the potential to become entangled in pumps and/or treatment equipment and could result in plugging and/or possible equipment damage and/or process deficiencies. The travelling bar screen is approximately 40 feet tall and 4 feet wide and is comprised of a number of moving metal screen collection panels which trap floatable debris discharging from the mouth of the interceptor. The unit is secured in a vertical guide rail system within the wet well of the raw sewage pump station. The guide rail is designed to allow the travelling screen to be slid in or out of the wet well when necessary. Below is a picture which provides some perspective on the size and configuration of the travelling bar screen.

On Saturday, May 16, 2020, alarms notified WWTP staff that the travelling bar screen was not operating. It was determined that the lower screen panels in the interceptor discharge area had been blocked with trapped debris. It appeared that one or more of the moving screen panels had become jammed somewhere below the surface level of the raw sewage. The blockage of the screen caused the interceptor pipe to backup with raw sewage. This backup resulted in a small quantity of untreated raw sewage bypassing directly into the St. Lawrence River. The spill was reported to the Ministry of Environment, Conservation and Parks.

In order to prevent further bypass of untreated sewage, WWTP management immediately ordered the rental of high capacity, portable sewage pumps to convey raw sewage around the inoperable travelling screen. Installation of the pumps instantly prevented further bypass of raw sewage and the pumps also did manage, over the course of days, to slowly lower sewage levels in the interceptor thereby alleviating potential basement flooding. Lowering the level of the incoming sewage also eventually allowed WWTP staff to visually assess damage to the bar screen. It appeared that components of the travelling bar screen superstructure had somehow twisted thereby causing the moving screen panels to jam in their tracks.

Although not confirmed, the cause of the failure is suspected to be a result of large quantities of used sanitary wipes being disposed into the sewage system. It is believed that residents are disposing substantially more sanitary wipes which had been used to implement disinfection procedures in an effort to prevent contraction of the COVID-19 virus. It is suggested that a large influx of used sanitary wipes accumulated on the lower bar screen panels resulting in excessive pressure exerted on the blocked screen panels by incoming sewage causing failure of the bolts securing the guide rail system to the wet well concrete walls. This in turn caused components of the travelling bar screen superstructure to twist when the panels attempted to move upward.

Upon subsequent inspection, it was determined by the manufacturer of the bar screen, that repairs could be performed to make the unit fully operational. Management staff have authorized the work which has required the bar screen to be transported for repair at the manufacturer's facility in Saginaw, Michigan. It is anticipated that the repaired travelling bar screen will be shipped back to Cornwall for reinstallation during the week of November 30. In the meantime, WWTP staff manually clean a backup, non mechanized bar screen on a daily basis.
