# Fly Creek Pumping Station

*Inspection*

Raisin Region  
Conservation Authority

January 30, 2019

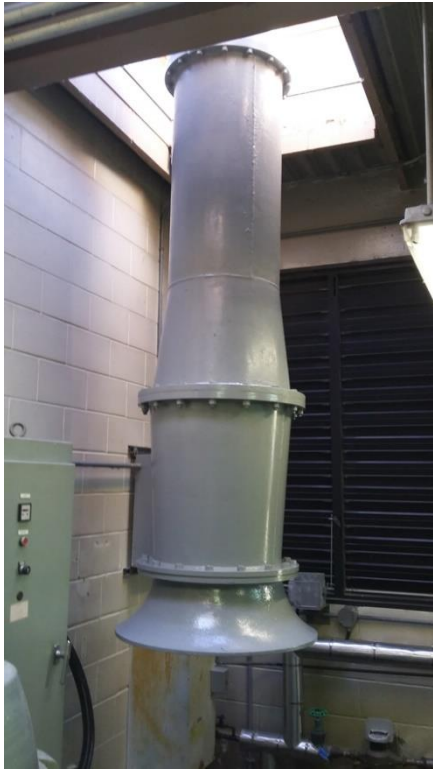
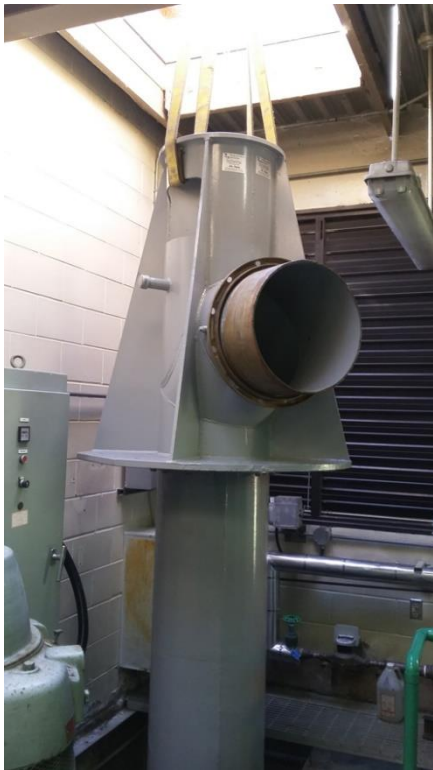
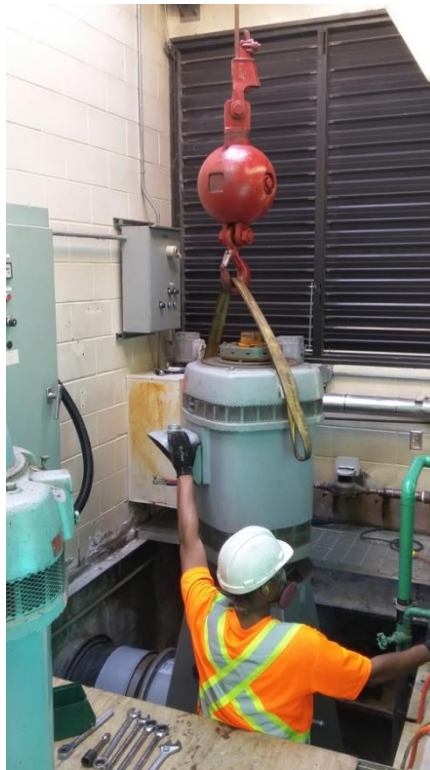
When Pump #3 was re-installed it was noted too that the soleplate was corroded and requires replacement as it is not likely to provide a stable base for operation. The motor was also found to be out of balance. It was rebalanced; however, vibration analysis indicates that there is likely a bearing defect in the motor that requires immediate attention. There is some minor leaking on at the discharge gasket of this pump which should be monitored.

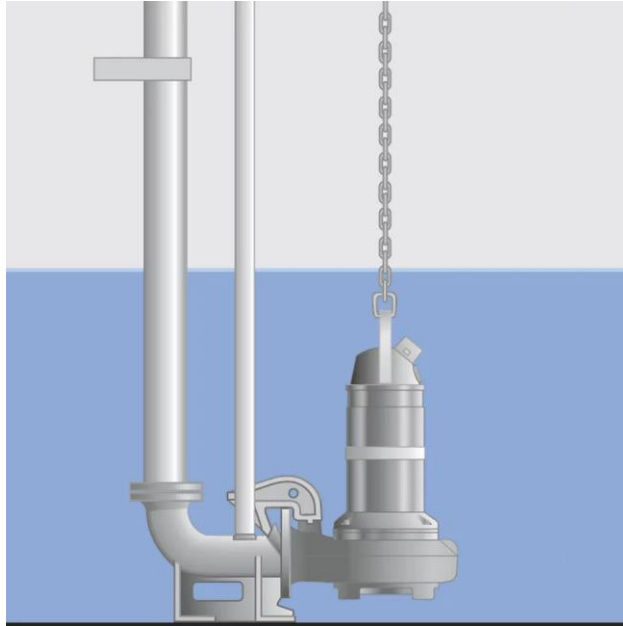
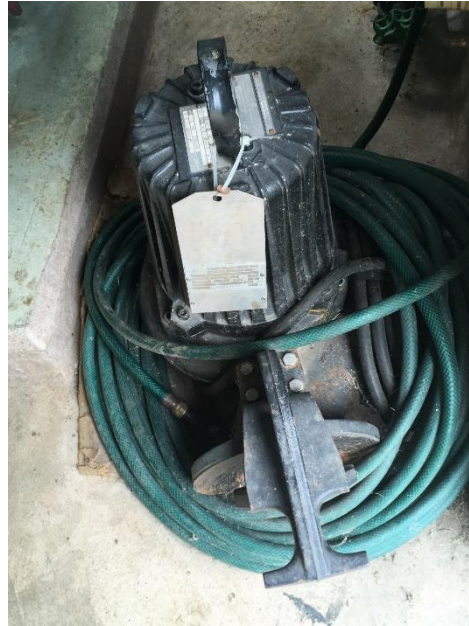
The dewatering pump was known to be acting up in recent years and would cause the breaker to trip immediately on start up. It was uncertain if there was a mechanical problem with the pump or an electrical problem. During the inspection, the pump was being hoisted by it's connected chain, which snapped (due to corrosion) and the pump fell to the bottom of the pond well.

A replacement pump was purchased in 2006. The model number is Flygt 3127. This pump could possibly be used to replace the original pump.

It is recommended that the pump be retrieved by a qualified person (confined space, diver); and inspected for repairs. A suitable chain should be selected for securing the pump

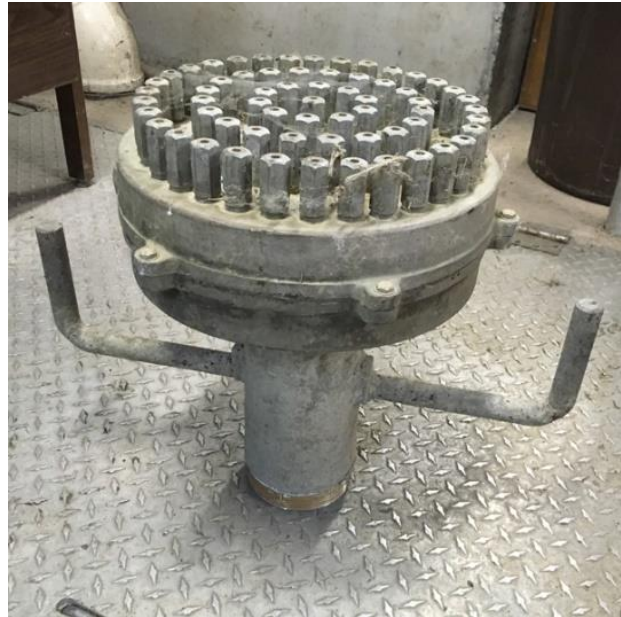
**Figure 32: Wetland Fountain Head**

The diversion actuator appears to be in good physical condition; however, at the time of inspection it was not possible to check the operation due to the controls having been removed during the last SCADA system update. Moreover, as the dewatering pump has not been working as of late, it is not possible to check the flow to the wetland. The wetland fountain head, which is to be removed for the winter, appears to still be in good condition. The wetland itself has seen some significant seepage in the past few years and may be compromised through rodent burying.

It is recommended that the actuator controls be reinstated and tested, and that the wetland embankments be examined and repaired.

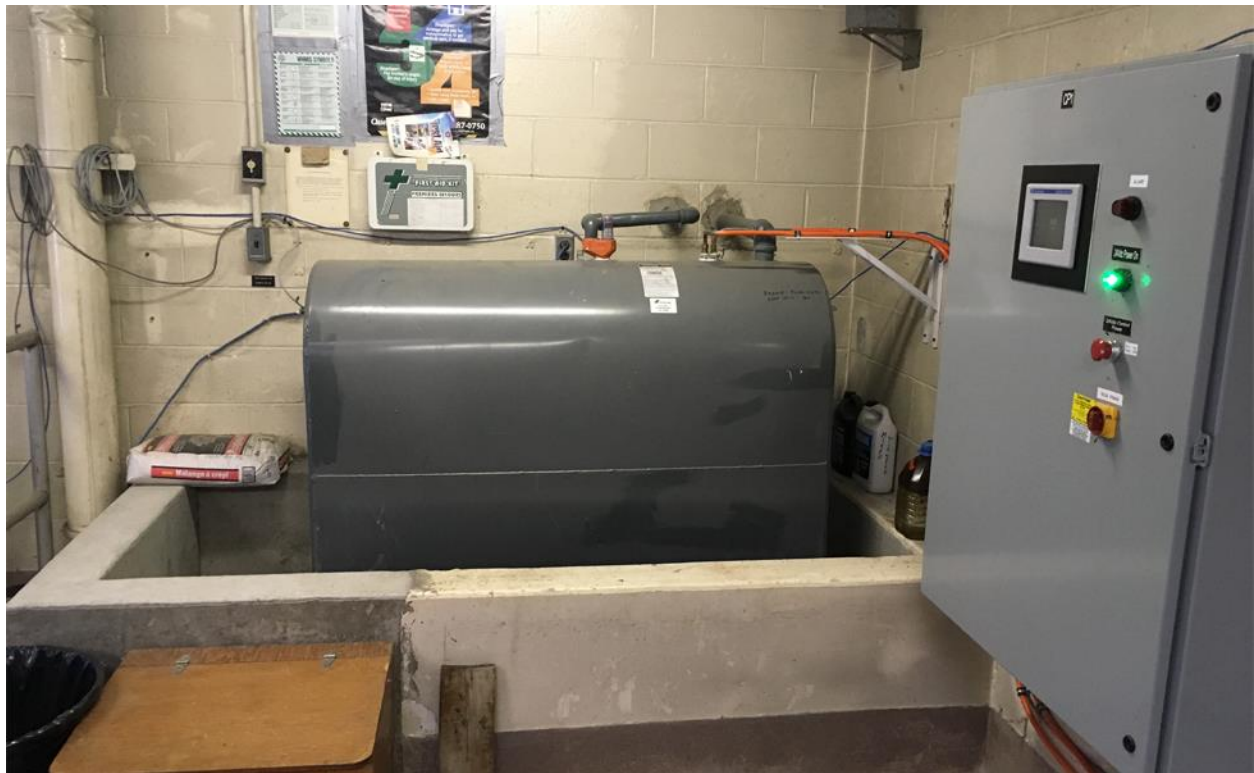
**Figure 38: Diesel Fuel Tank**

This current fuel system replaced a 9000L outside underground fibreglass tank and 450L inside day tank in 2006. The fuel storage tank has a manufacturing date of November 2006. The fuel lines were repaired in September of 2015. The tank was also fully inspected at that time. The tank, being located inside, is protected from the elements and is still in good condition and shows no evidence of corrosion or leakage. The secondary containment cell is adequately sized, it is clean and in good condition.

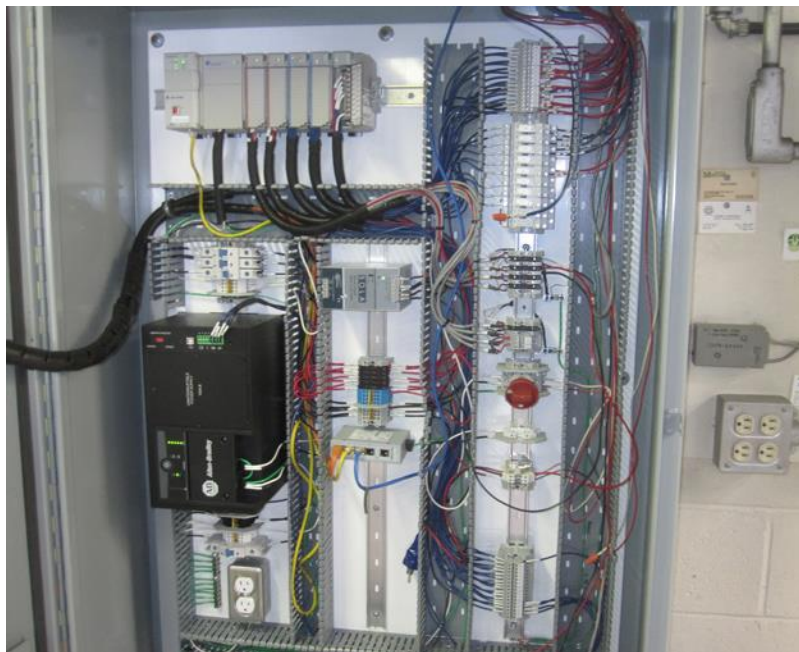
**Figure 39: SCADA System (Panel open, with wiring exposed)**

The current SCADA system is working as intended, in that the pumps are properly activating and deactivating at the pre-set water levels. The SCADA system interface as it is currently programmed does not permit easy modifications to operating rules. Additionally, there is no alarm mechanism implemented to alert of system malfunction or high-water level events. It is recommended that the SCADA system be modified to enable the human machine interface features to be accessible to operators for easier programming of features (i.e. adding/removing pumps from service); and, that suitable alarm routines be implemented.

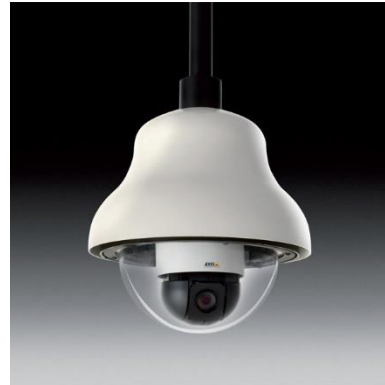
**Figure 47: Outside Camera Dome (Mfr. Photo)**

The current surveillance camera is non-functional, and the VPN connection has been disconnected. The camera is not critical to pumping station operation; however, it is an extremely useful tool. For example, an operator can make a quick visual check of water levels in the pond and make a remote assessment as to the proper operation of the pumping station. It is recommended that the camera be replaced or repaired immediately.

It would also be recommended that a security camera system be installed within the pumping station too. For a relatively low expense, this would enable the operations staff to review and possibly trouble shoot alarms remotely. It would enable staff add additional monitoring without the expense of physically visiting the pumping station.

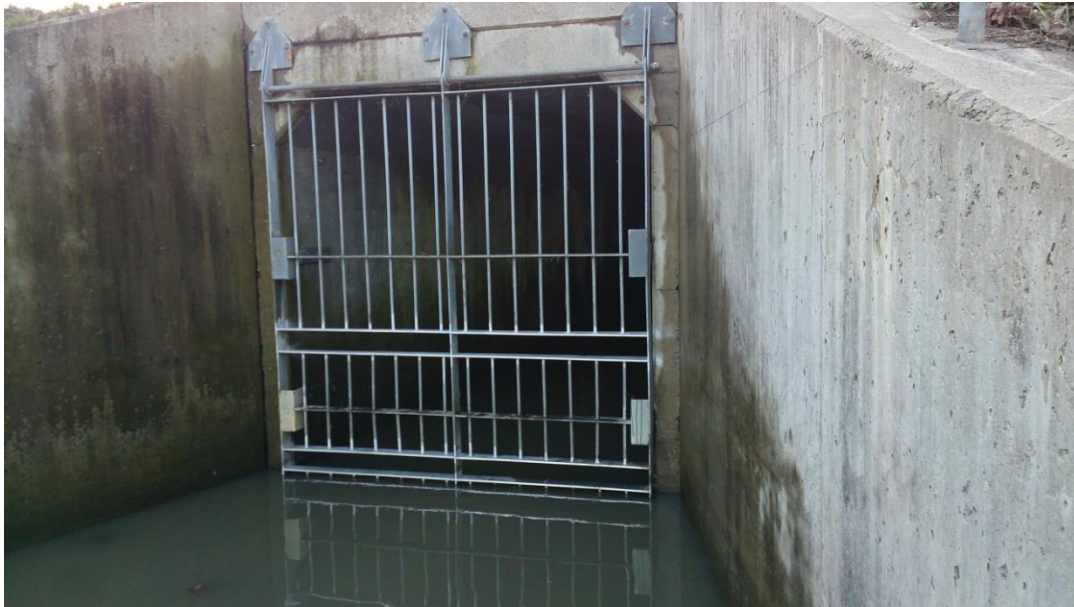
**Figure 48: Inlet Screen**

The inlet screen is firmly attached and is functioning as designed.

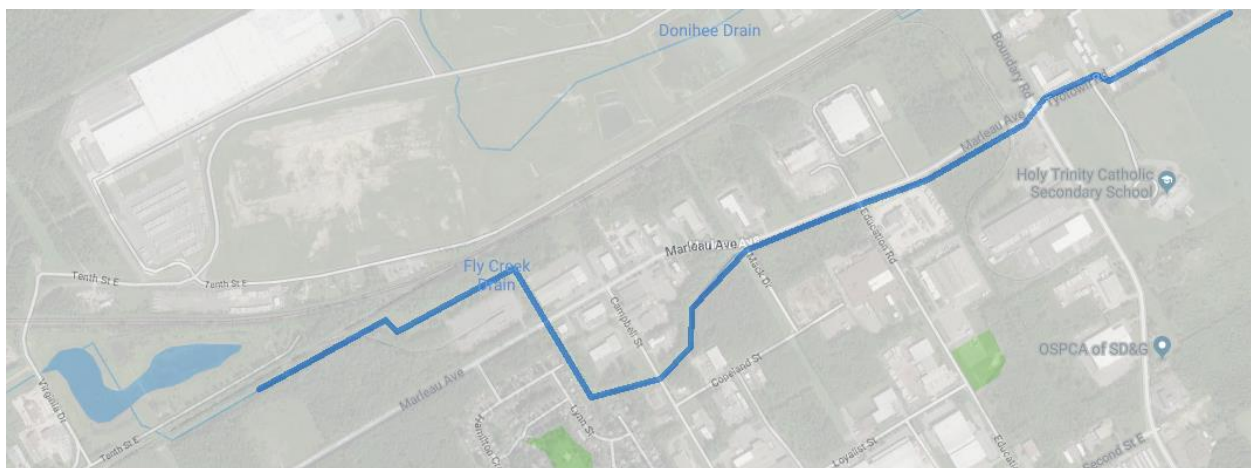
**Figure 49: Fly Creek Outlet Channel Route**

The channel is prone to becoming overgrown. It last saw a major clean out in 2014. In 2018 a beaver dam blockage was removed. The culvert under Campbell Street was replaced by the City of Cornwall in 2018. The channel could see flows in the order of 2100 L/second – it is imperative that regular maintenance and inspection be performed to ensure proper operation. The current condition is assessed as adequate.
